# LONDON- WEST MIDLANDS ENVIRONMENTAL STATEMENT

CFA11 | Stoke Mandeville and Aylesbury

**Survey reports (CH-004-011)**

Cultural heritage

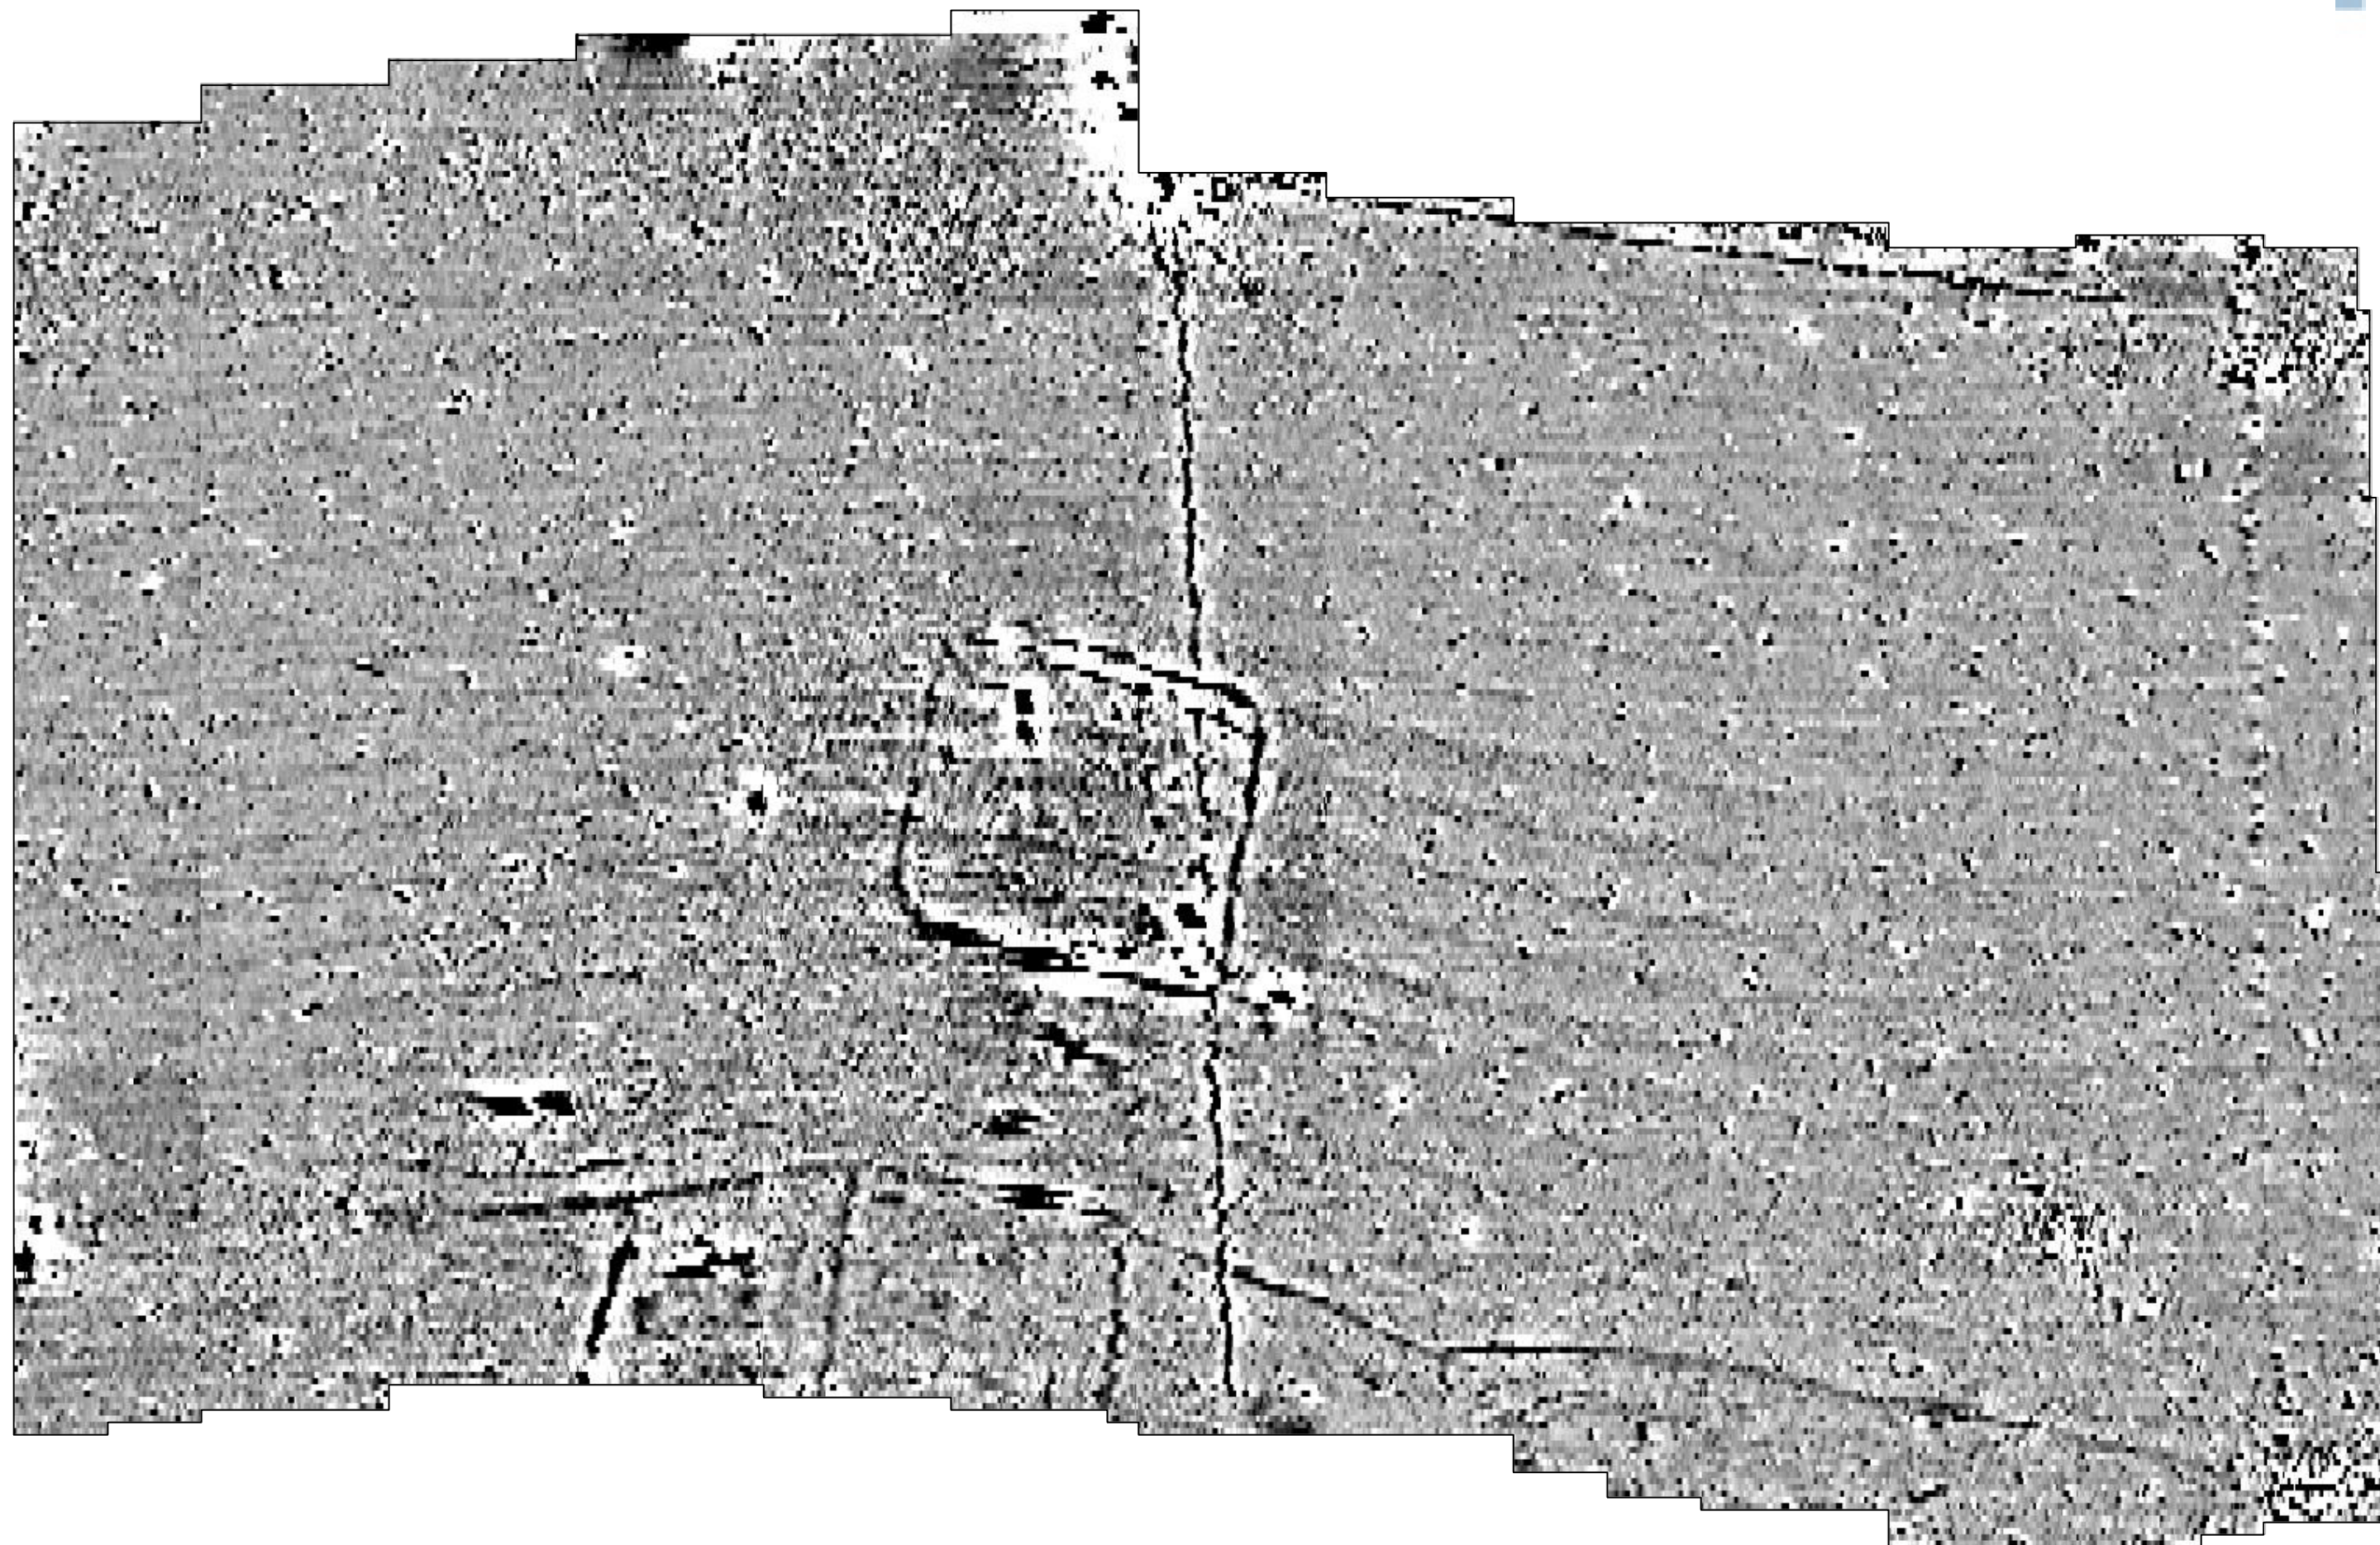
<b>Project:</b> G1317/2 HS2: C252 Country South CFA11 IB0AA(2) St Mary's		
<b>Title:</b> Magnetic Data - Area 2: Greyscale Plot		
Drawn by: JMT		<b>CH-004-11.19</b>

- 3.2.20 Linear anomalies [3], towards the south-eastern boundary of Area 2, are of probable archaeological origin. These anomalies appear to form a series of divisions abutting a main spine ditch which runs north-east/south-west. Trend [5], in the north-western part of Area 3, may form a southern edge to these divisions. Some doubt is introduced due to the significantly-reduced magnetic response of ditch [5], although this reduced signature could have been caused by the necessity for the instruments to be carried at a greater height in Area 3 (due to the taller vegetation in this part of the site).

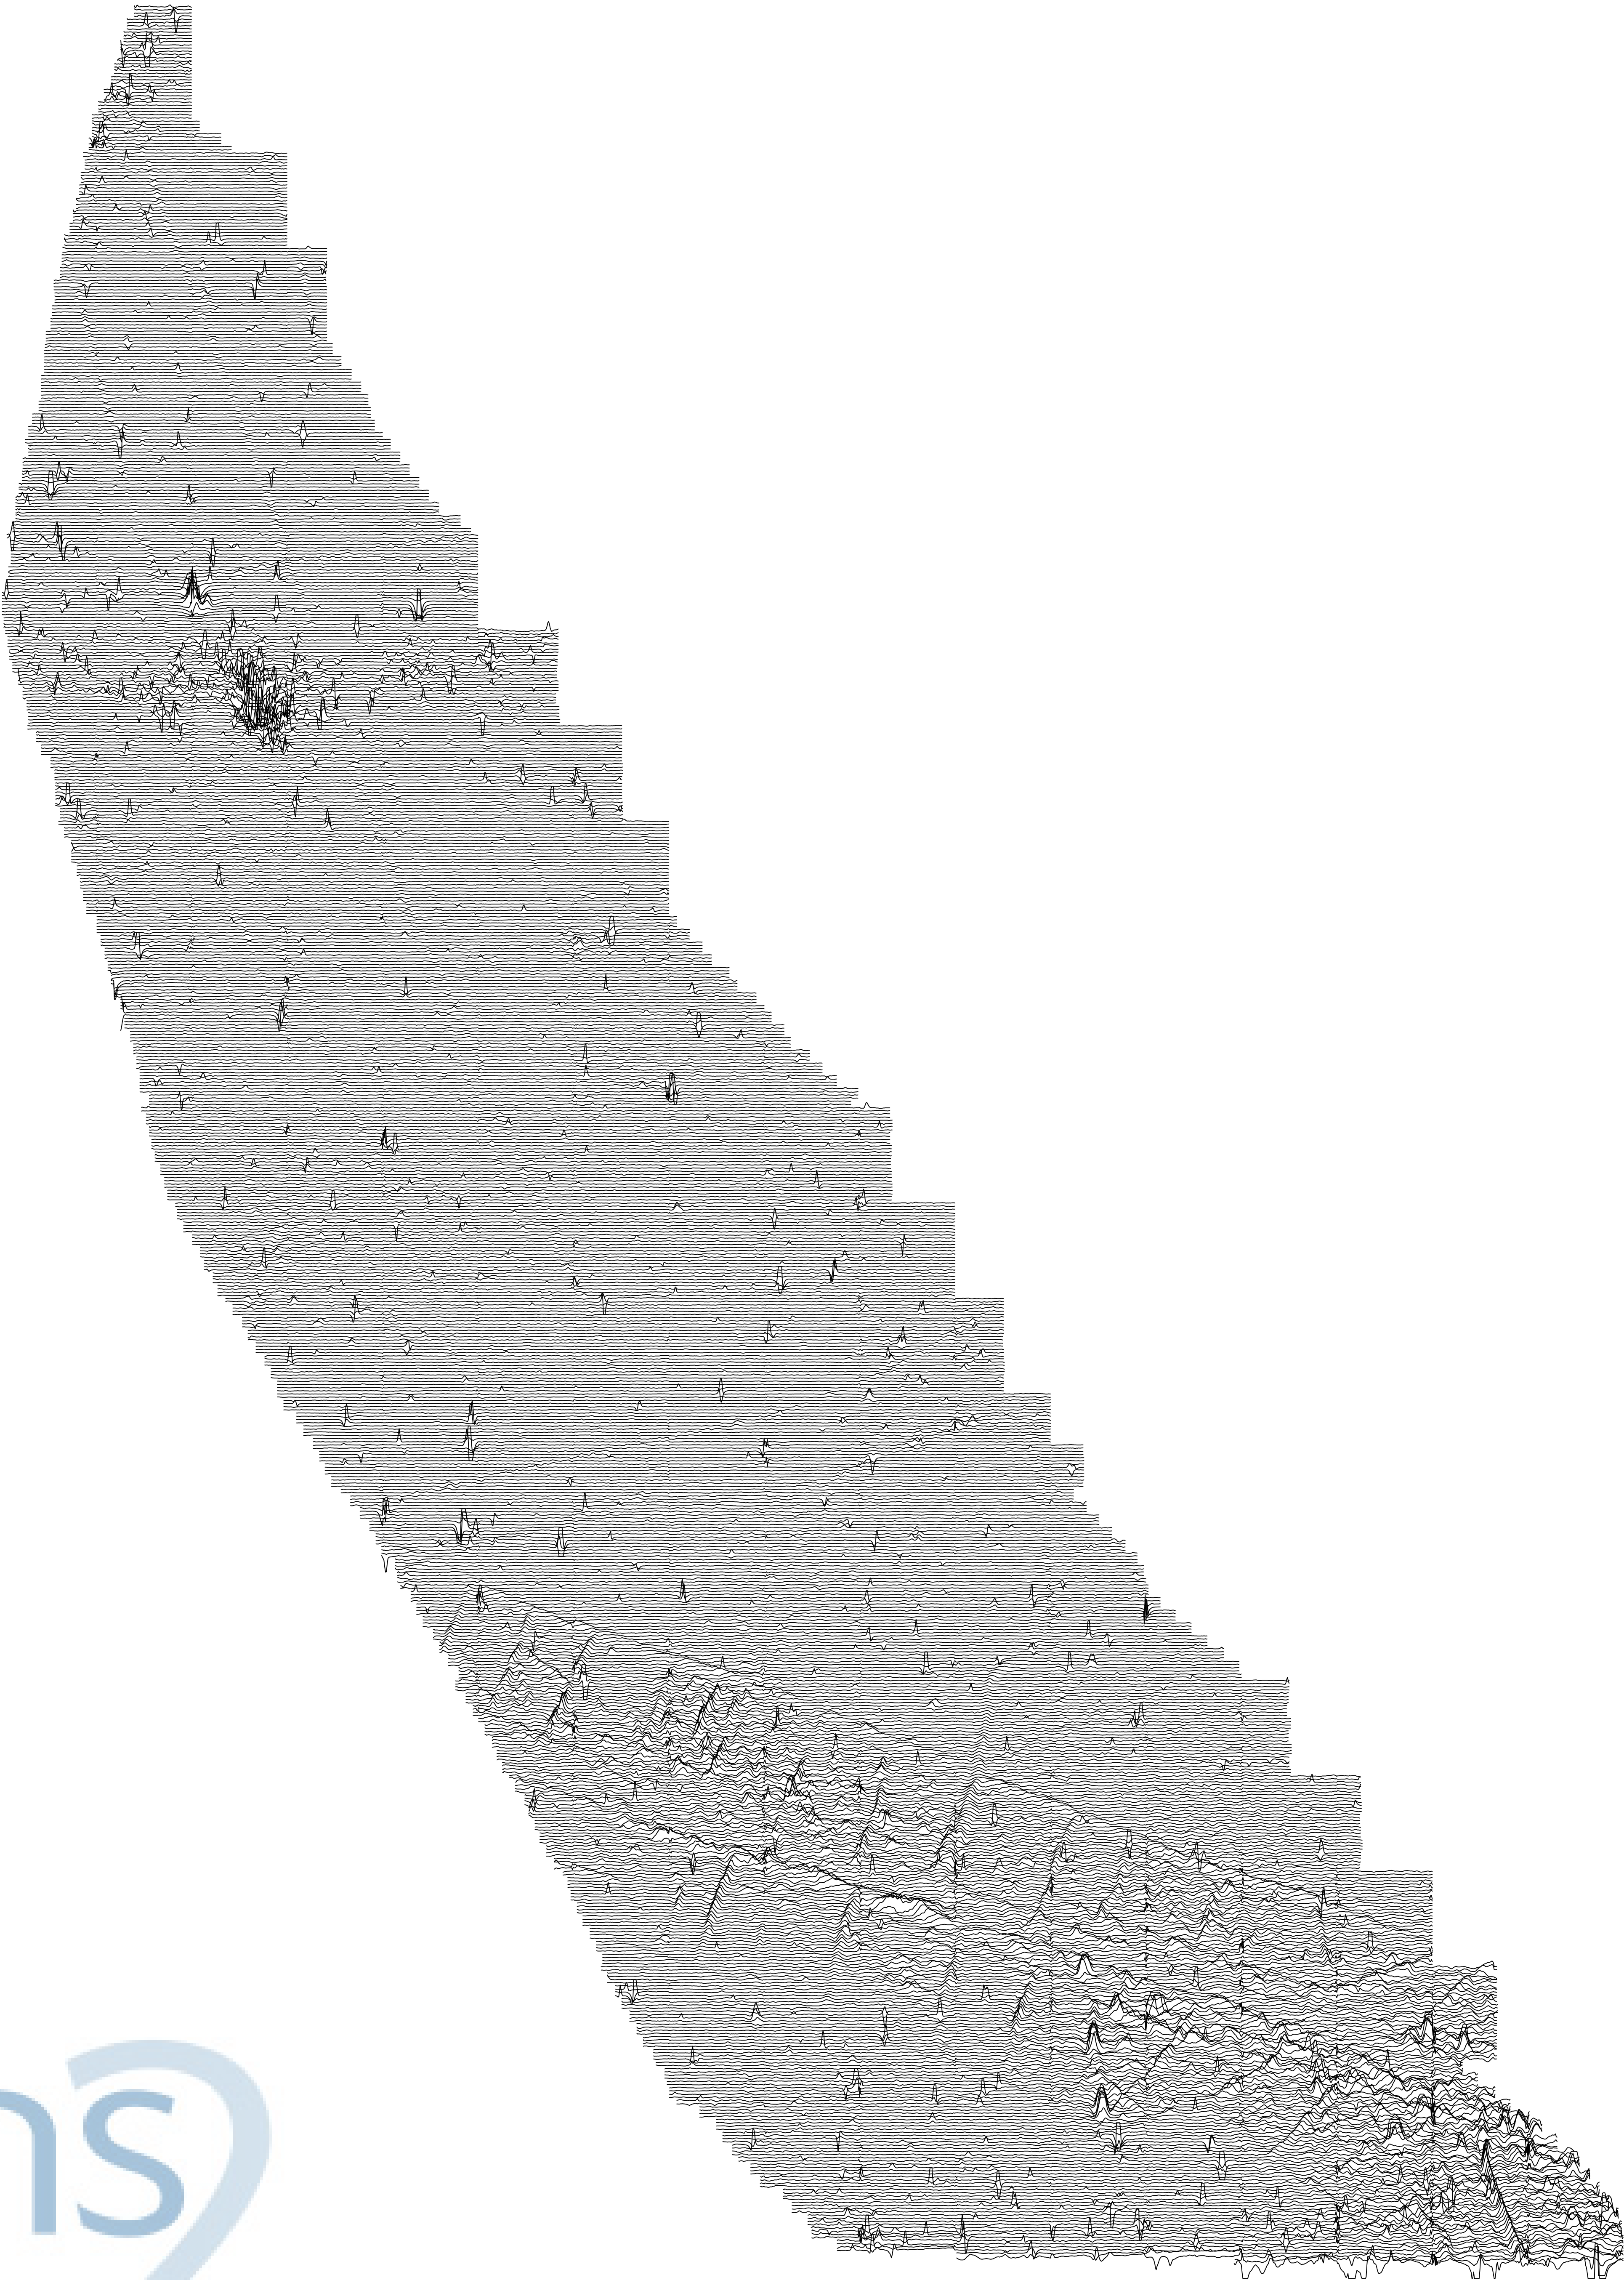
CH-004-11.58

- 3.7.18
- See Figure CH-004-11.58. A well-defined group of ditch-like anomalies forms a clear rectilinear pattern in the southern part of the site. The regular pattern of these features becomes more complex at the south-eastern limit of the survey site. Gaps in the linear responses may be genuine, indicating entrances into the plots, or the result of plough damage. Numerous pit-like responses are visible in the data amongst the linear anomalies. This complex is typical of a ladder settlement. It straddles the line of Roman Akeman Street (SMA076) and appears to extend beyond the survey limits to the south, east and west.

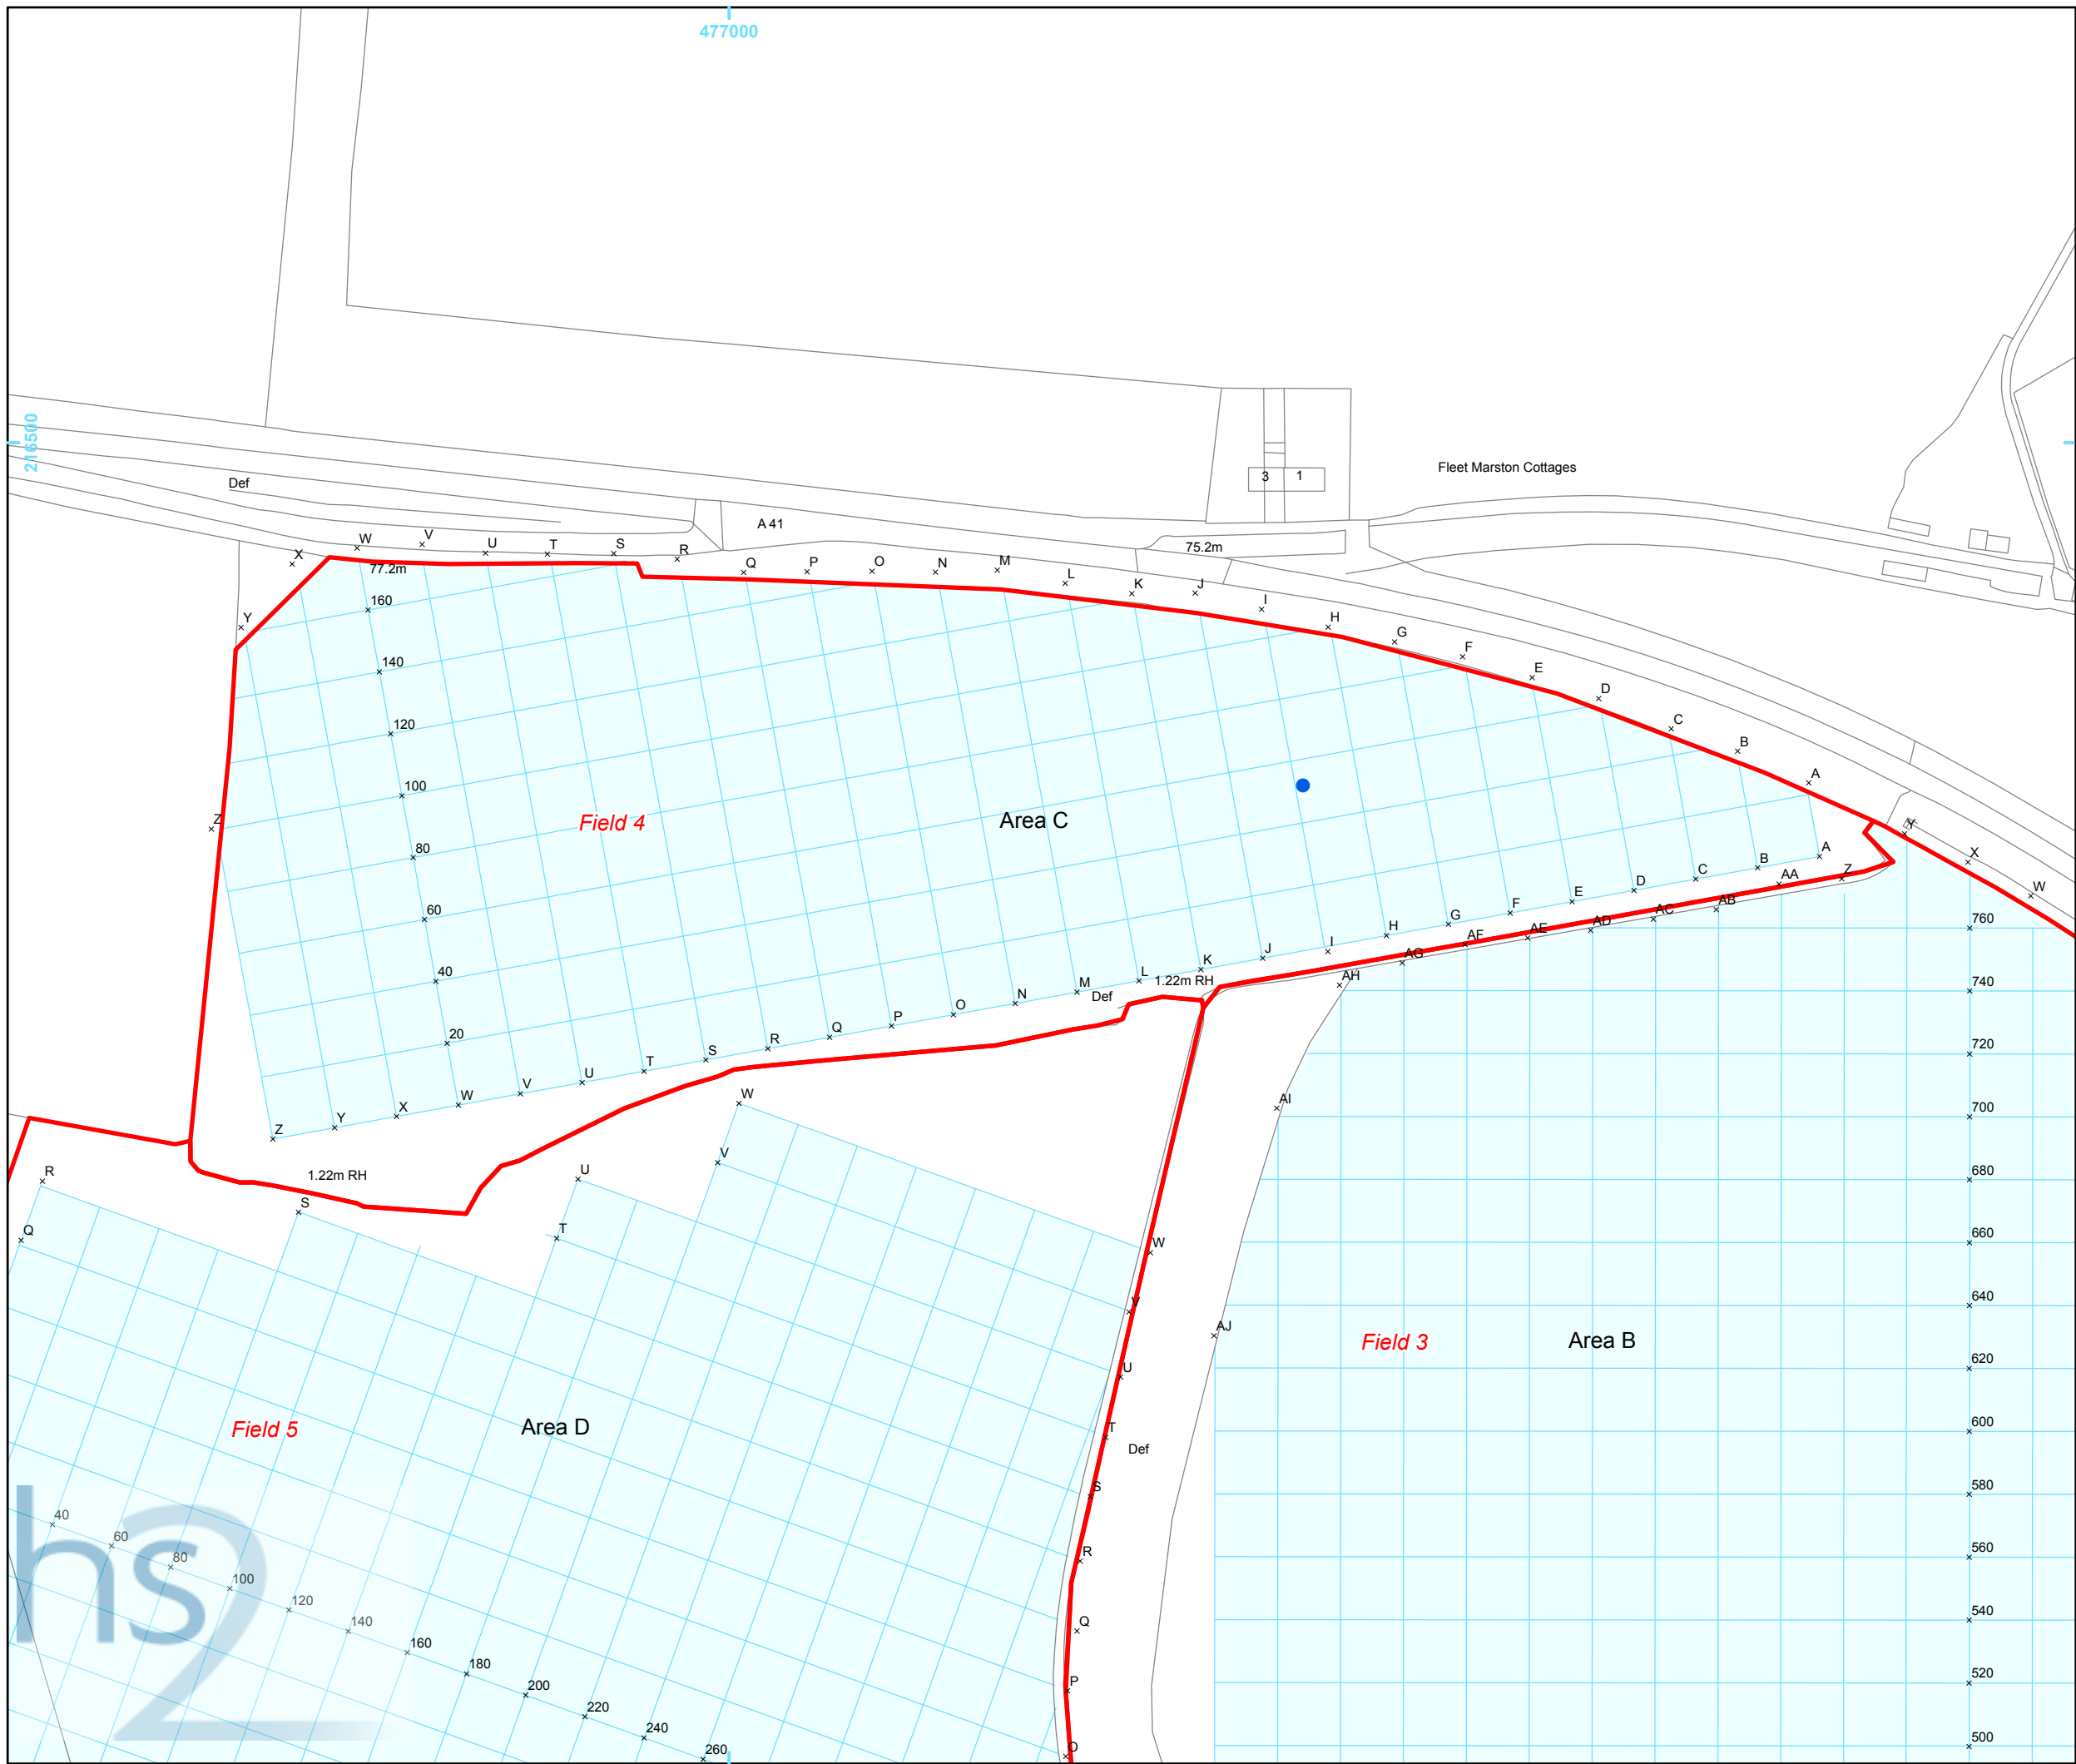
PROJECT NO. 660122 DATE 25-09-2013 FIGURE NO.  
DRAWN BY JB REVISION 00  
APPROVED BY PJM SCALE@A3 1:3,000 CH-004-11.79

FIGURE TITLE  
KBOAD:Fieldwalking Survey.  
Prehistoric finds
